Case Report

Jet Fuel at risk?

2 parallel jet fuel steel pipelines with PE coating.

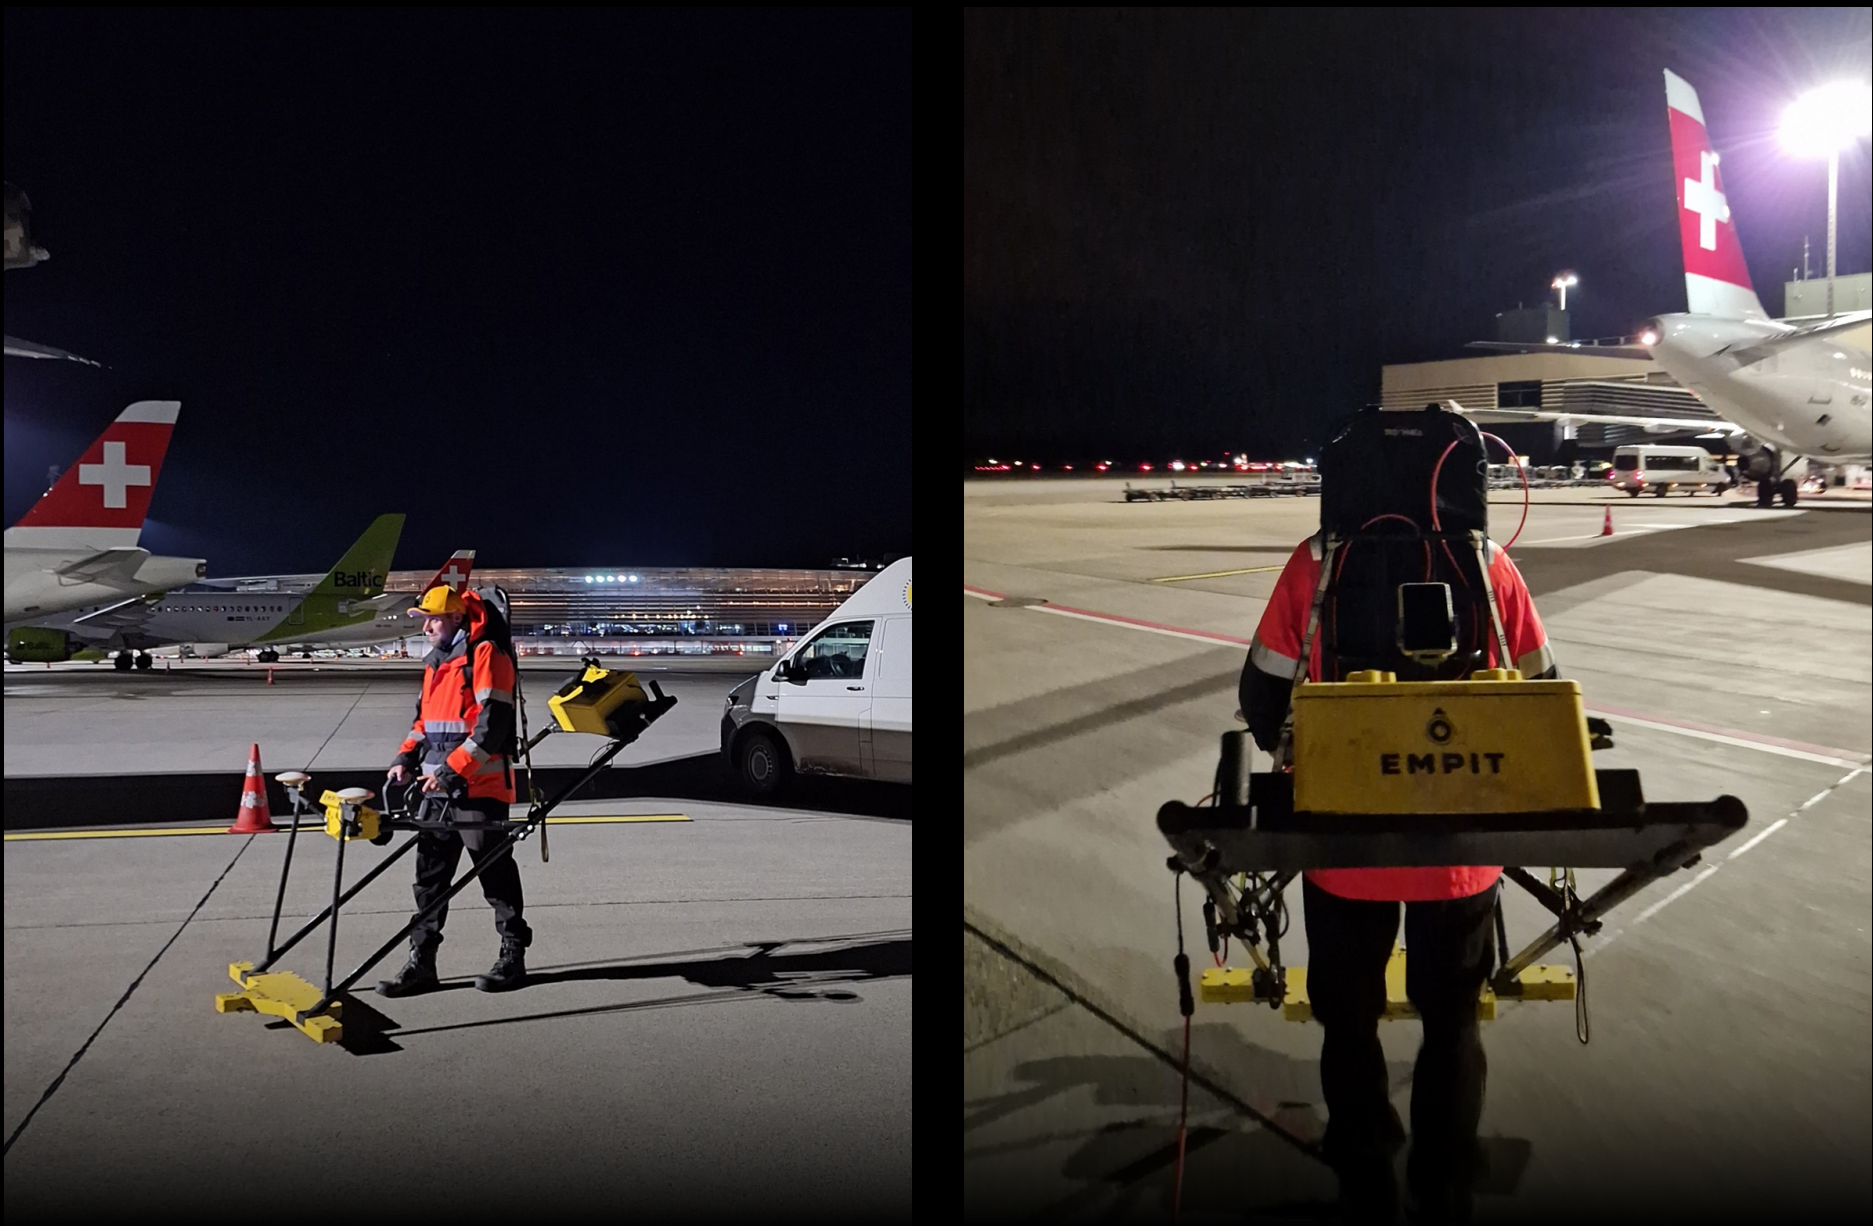
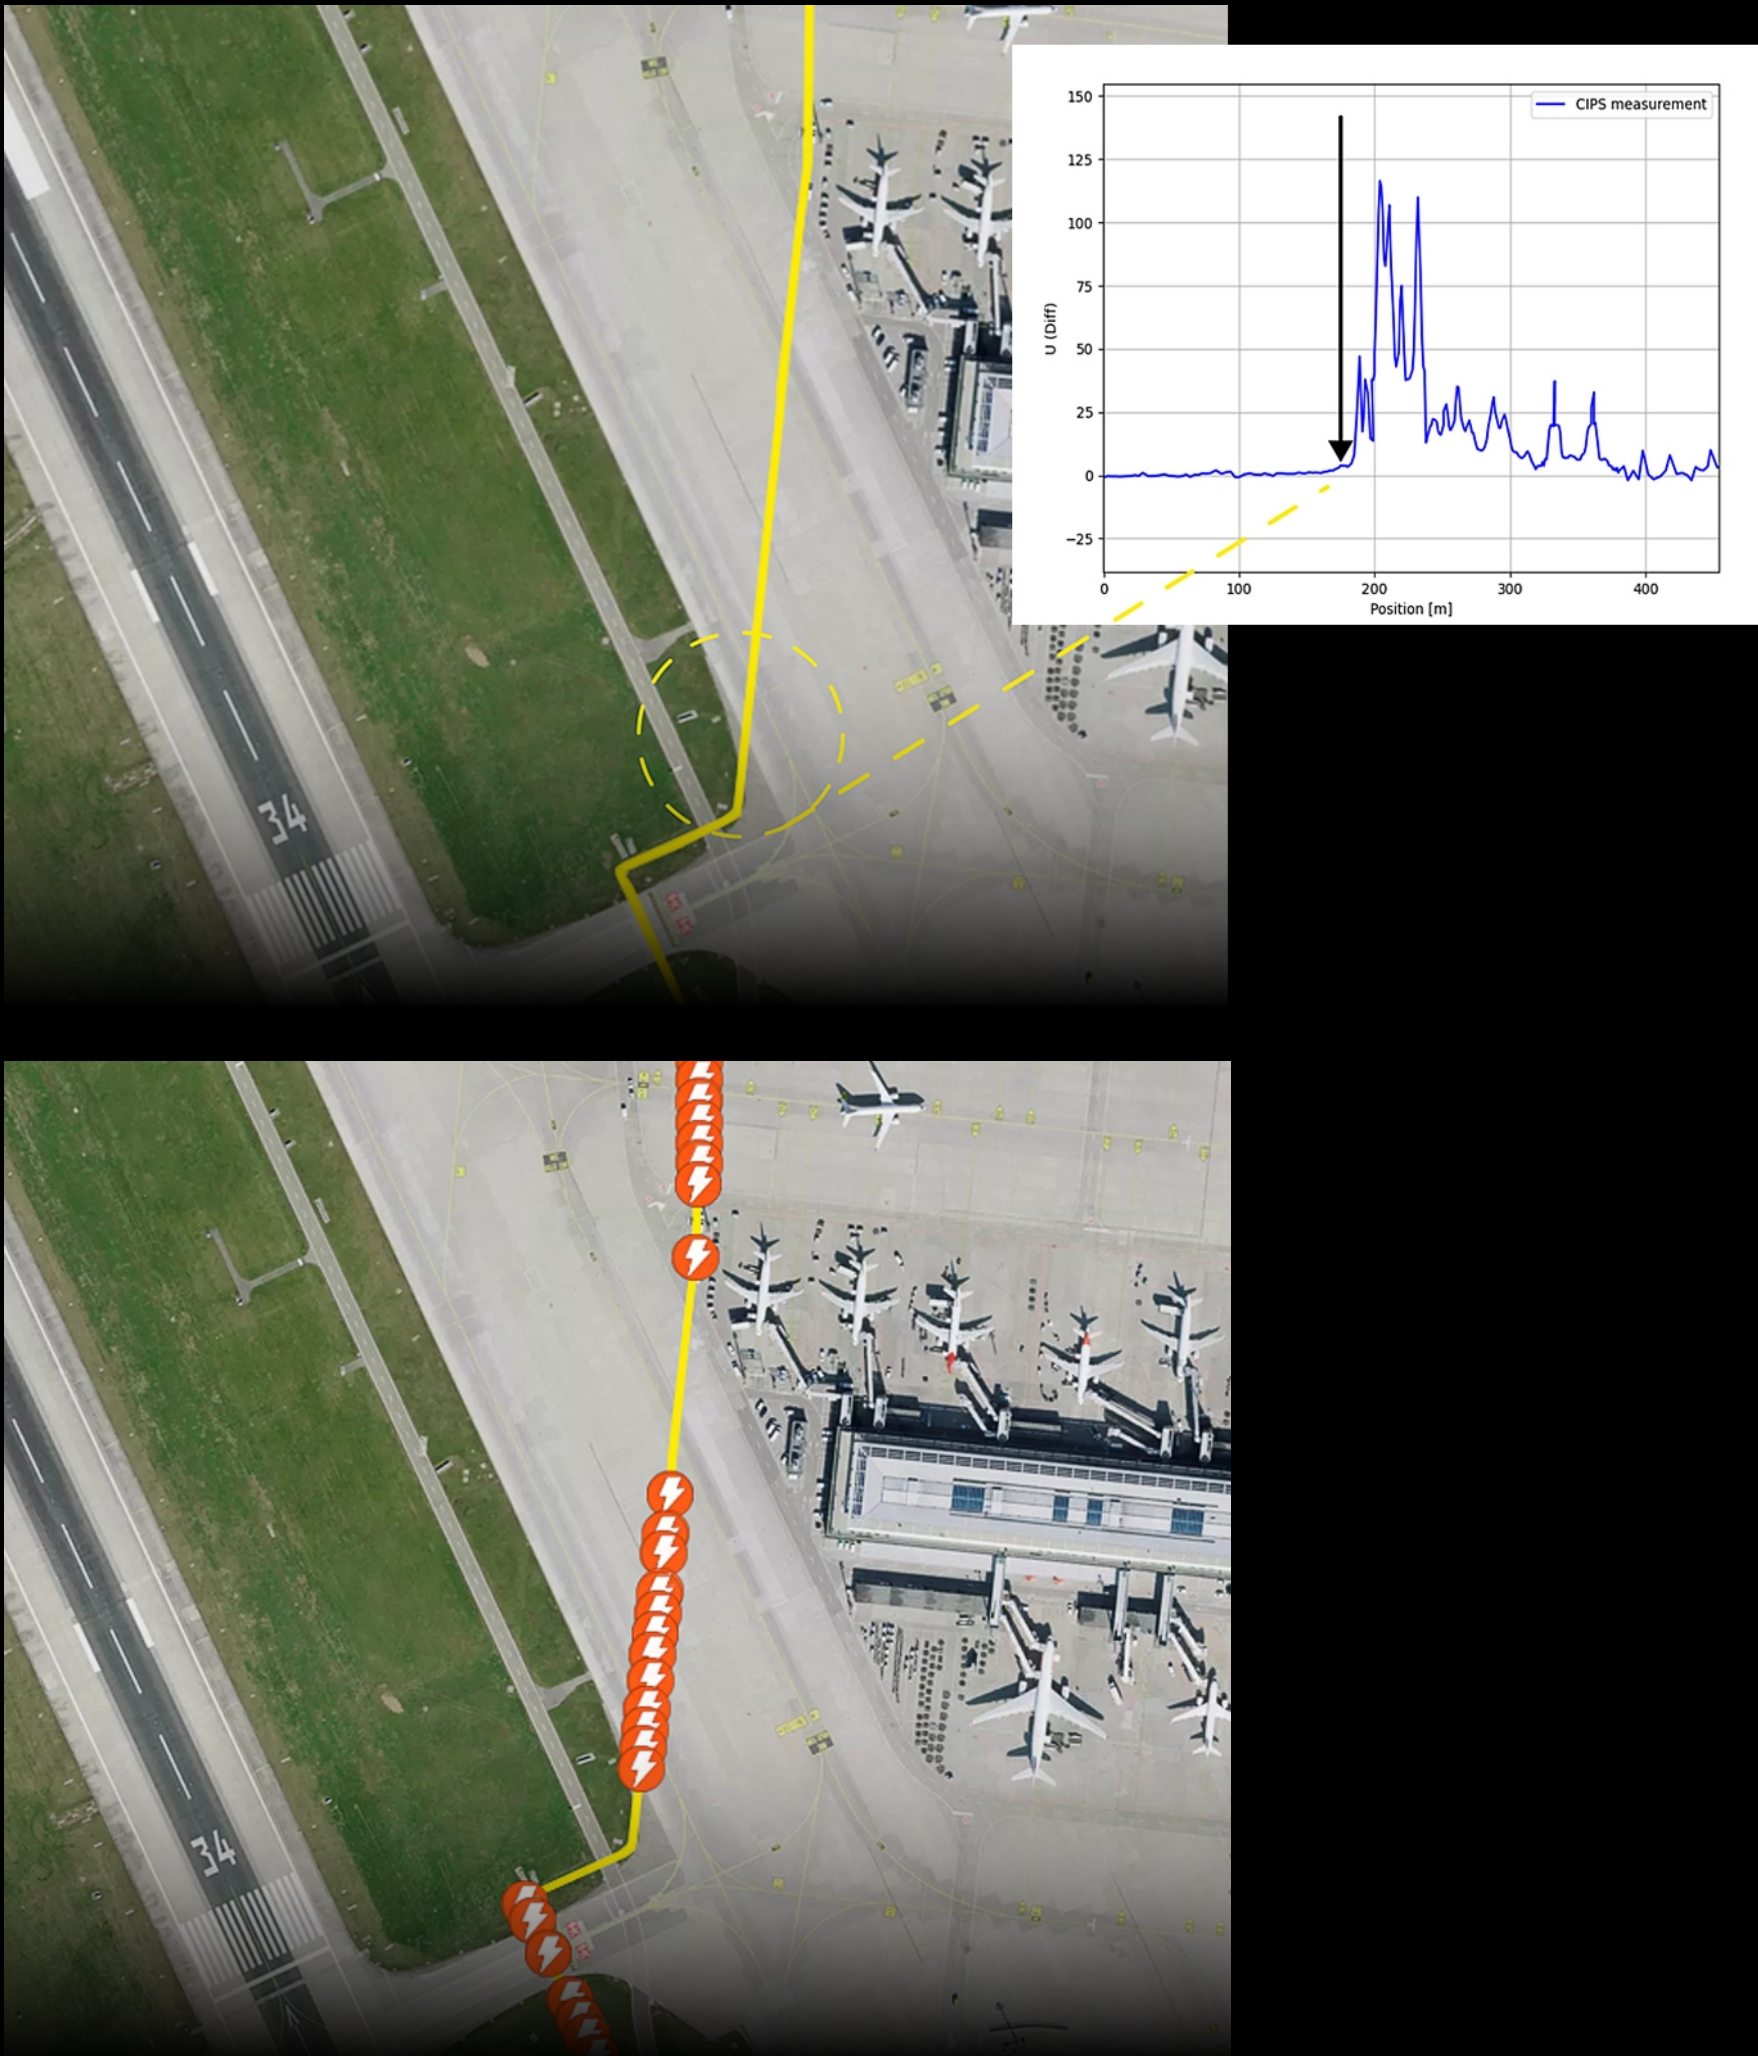
Using CMI, a total of 56 coating defects were detected and accurately localized—both adjacent to and beneath the asphalt surfaces of the terminal apron. For each coating defect, CMI additionally provided information on the presence of a passivation layer at the steel surface and the corresponding spread resistance.
